CADWALLADER TECHNICAL SERVICES

For: Leonard Water Services

Re: Inspection, Testing and Repairs of Geomembrane Construction at Braumley Dairy Raceway Basin, Hico, TX 4/25/07 and 4/26/07

April 26, 2007

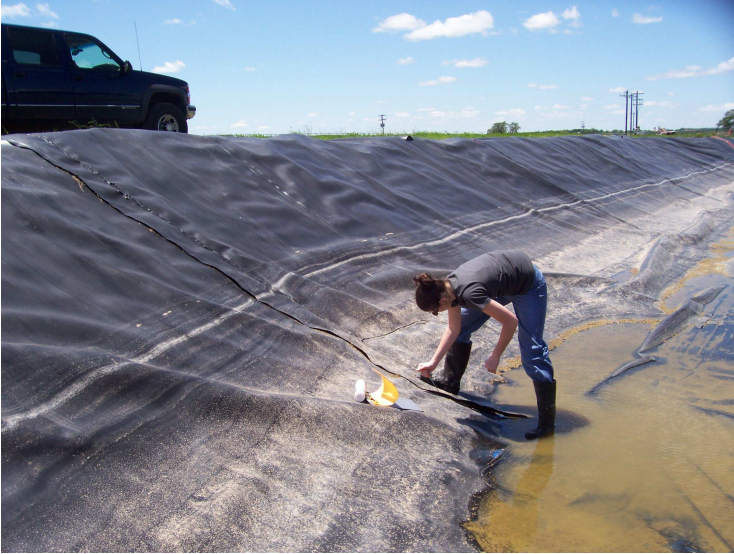
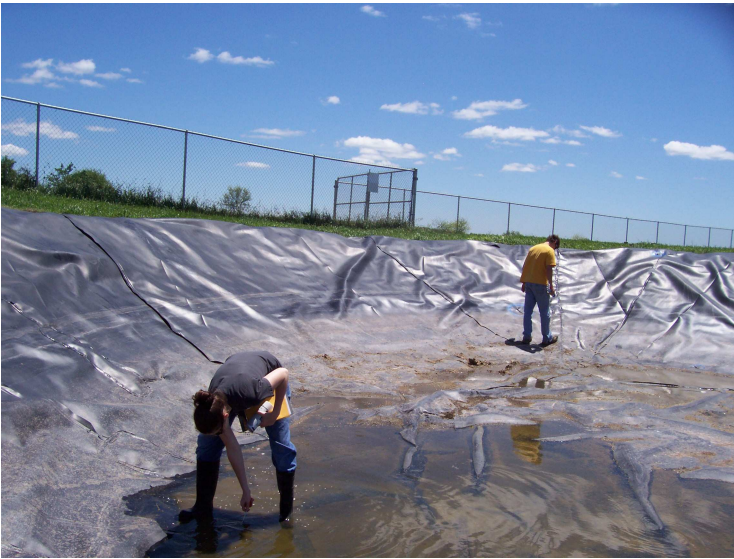
Probe testing for gaps in seams.

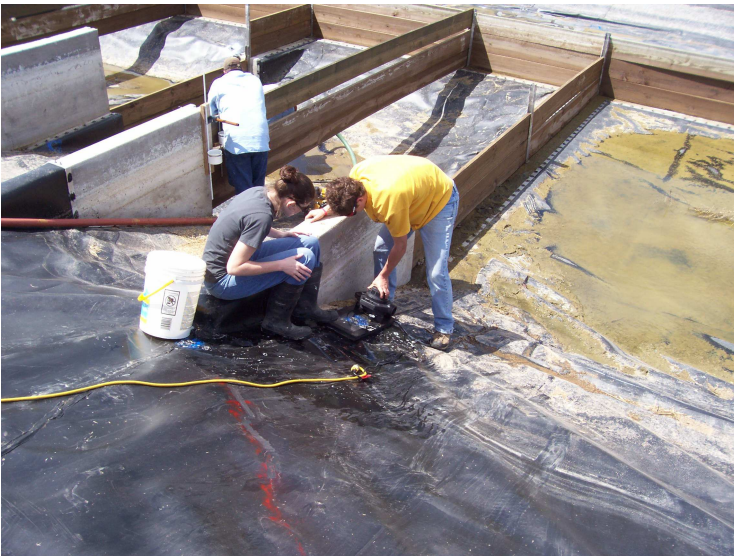
Vacuum box testing

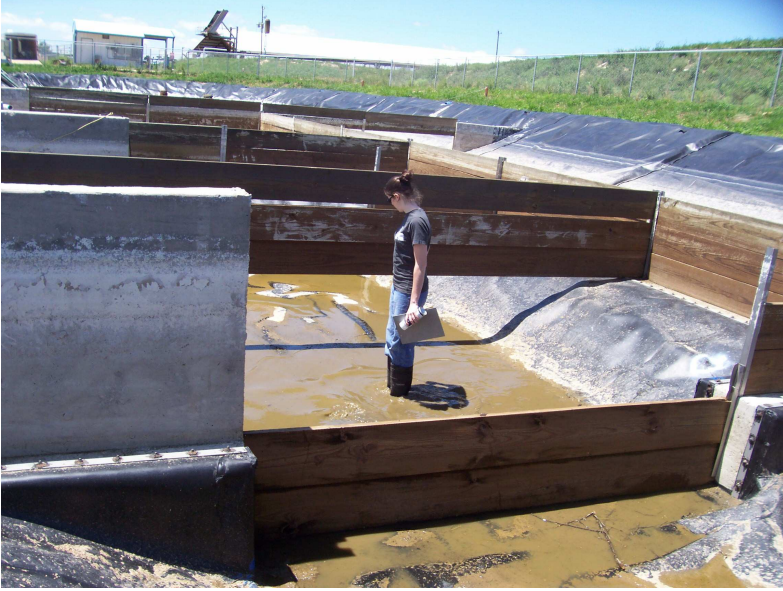
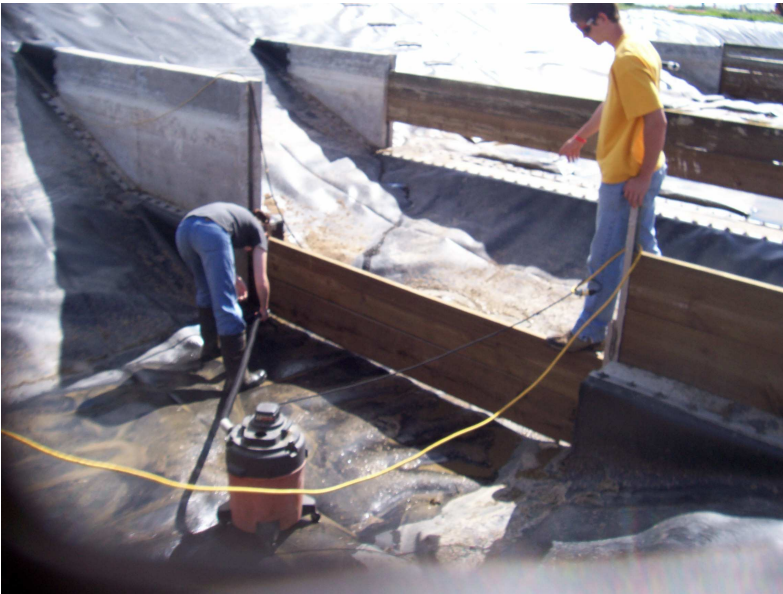
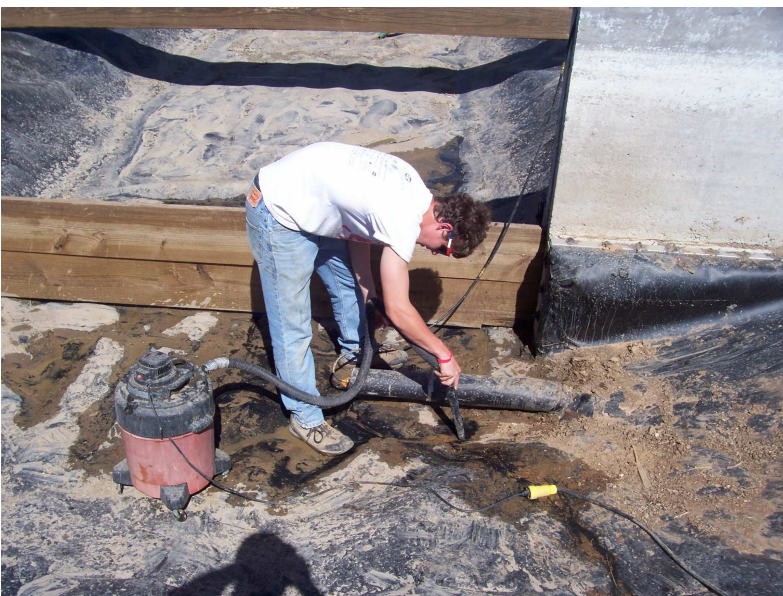
Middle low section of south side of raceway being water tested for leaks. Two holes found.

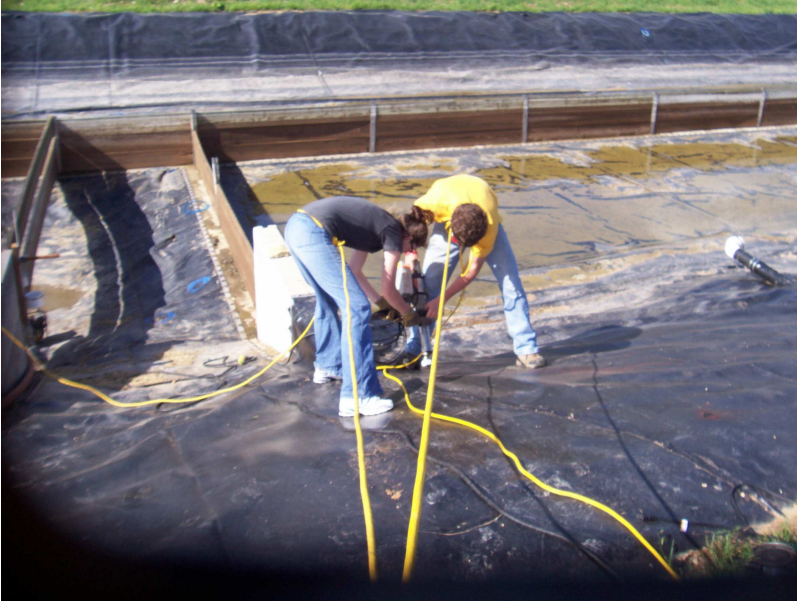
Repairing hole on south side-slope.

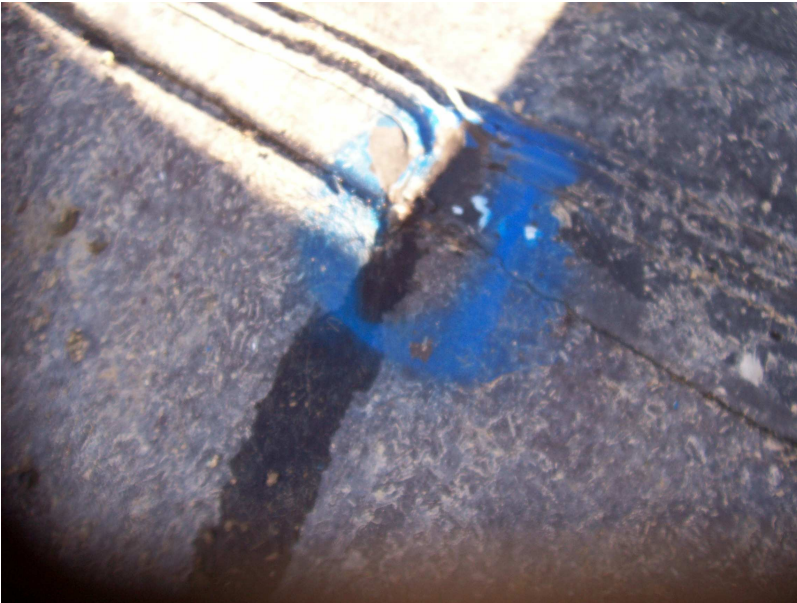
Seep at previously repaired Poly-Lock joint attachment at concrete slope in aeration pump section.

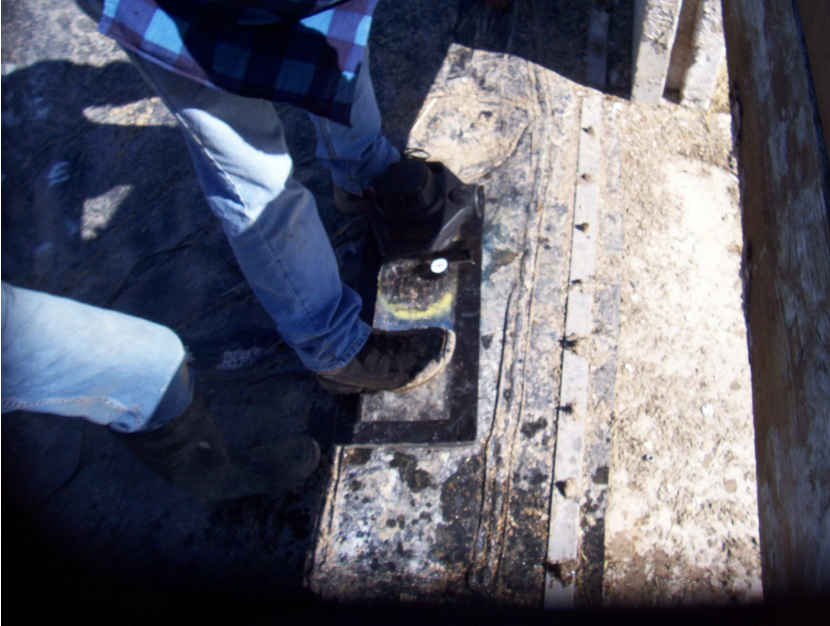
Vacuum testing patch along west wall of aeration pump section where 3 leaks were found with v.box testing.

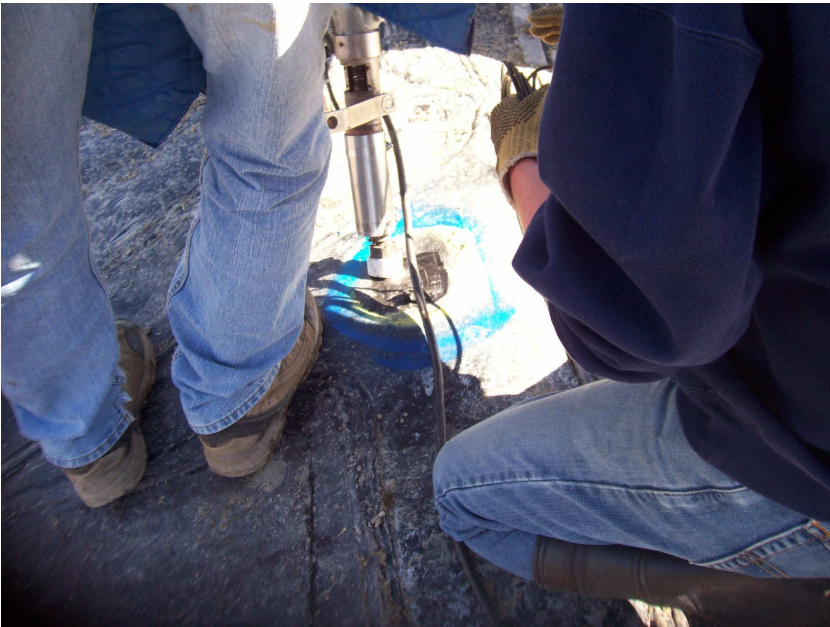
Welding the leaking epoxy glued patch.

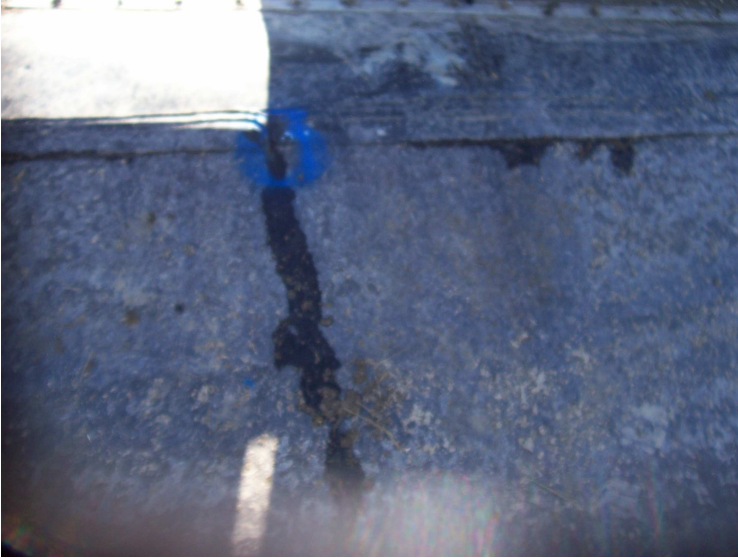
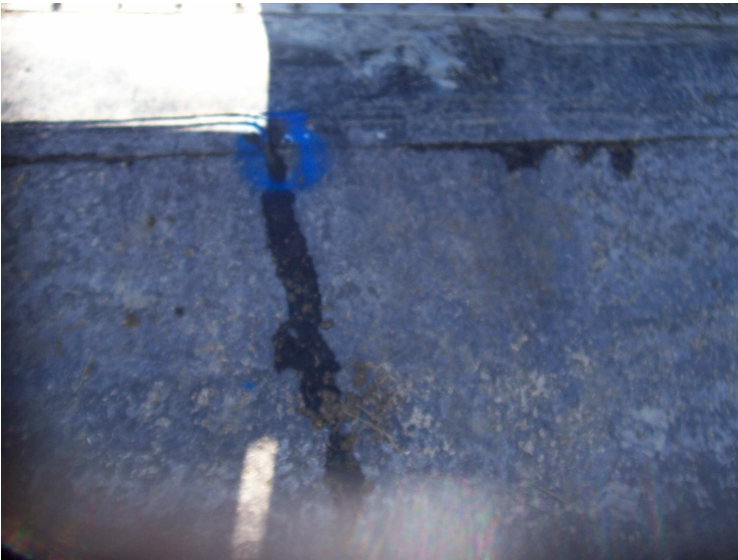
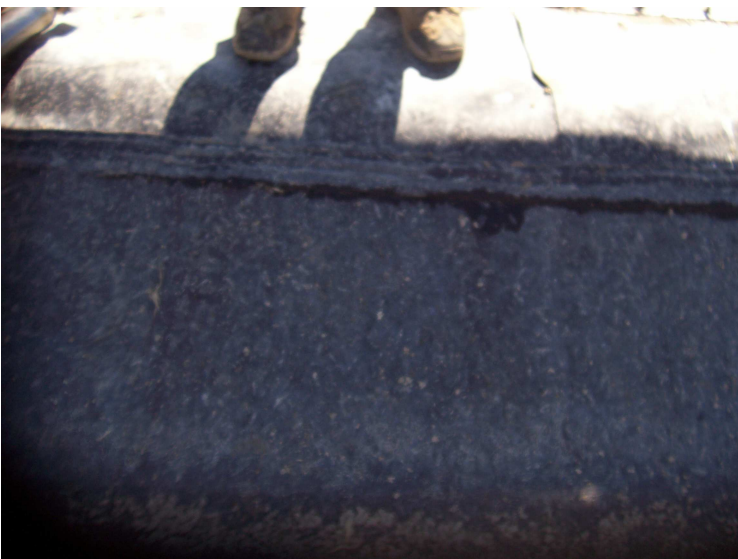
Seepage showing along concrete/Poly-Lock interface from back-water pressure.

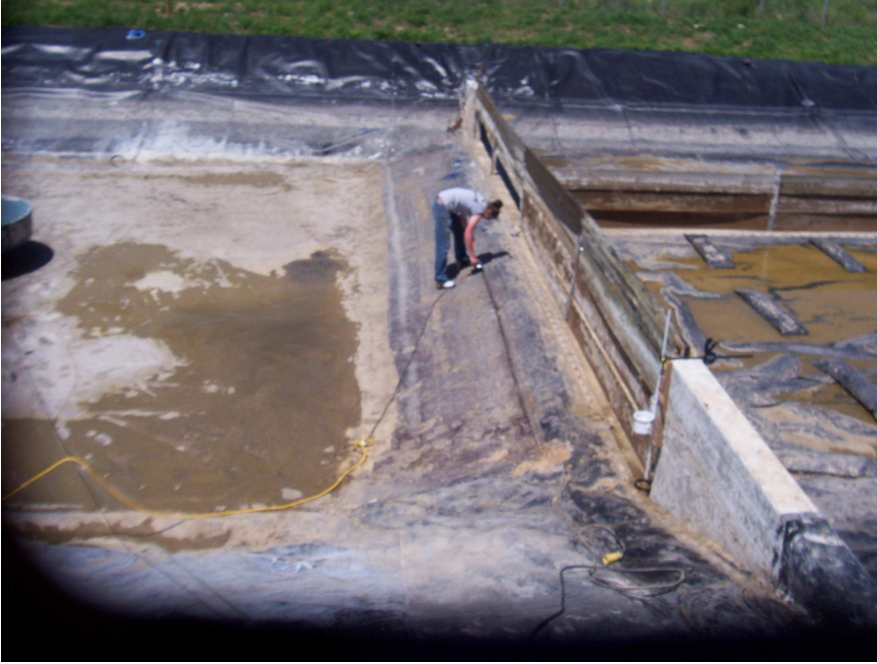
Prepping concrete/Poly-Lock interface with abrasion before sealing with two part epoxy. Note remainder of concrete pad too covered with sludge to inspect well enough.

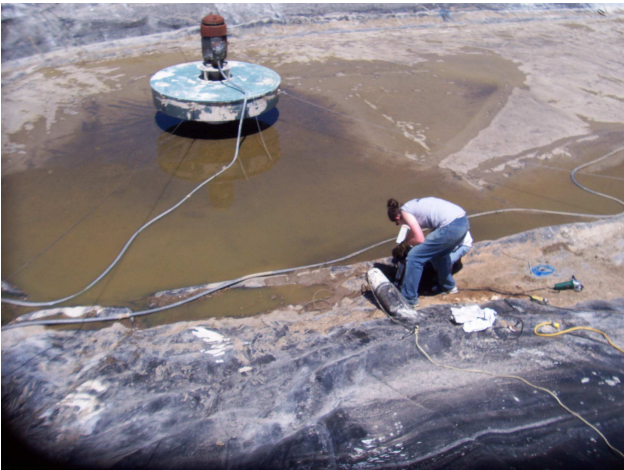
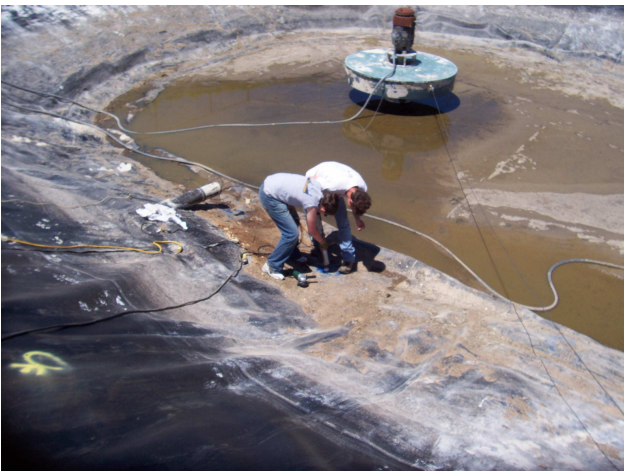
Two holes discovered in liner at aeration pump section properly repaired to be leak free by v.box testing. Water behind liner revealing leaks was pumped out in advance of heat seam repair.

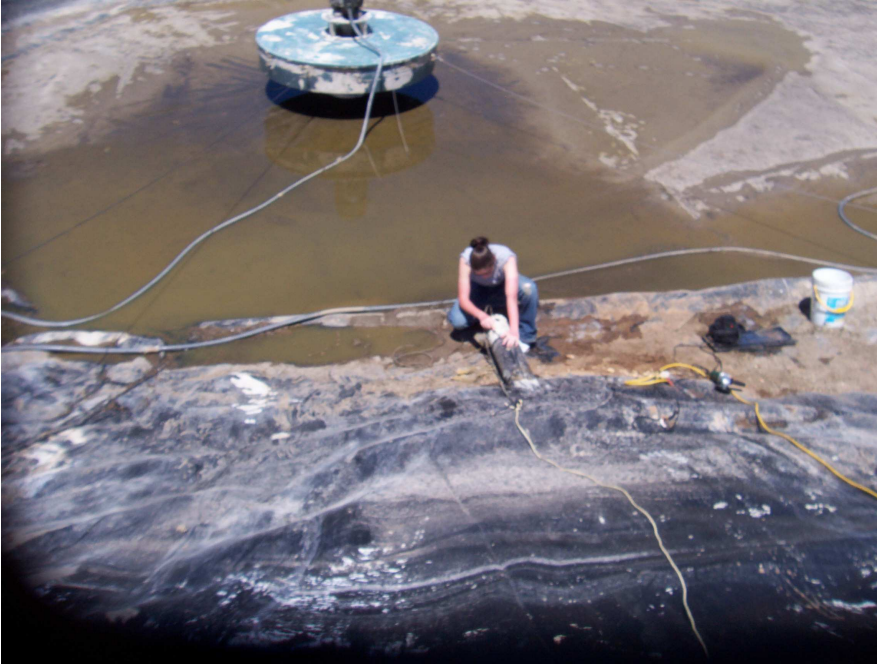
Probe testing steel band attachment of PE skirting to PVC pipe.

Gaps in connections around pipes were found. Where possible to extrusion weld pipe boot to HDPE this should be done. Completion of repairs on leakages discovered was requested and agreed upon for Monday April 30, 2007. While nothing "huge" was uncovered, many smaller holes and leakages were found, including seeps in concrete-to-plastic connections.
